**OPERATION AND MAINTENANCE INSPECTION  
STORMWATER MANAGEMENT SYSTEM**

**GULL AIRE VILLAGE  
151B GULL AIRE BLVD  
OLDSMAR, FL 34677  
PERMIT # 40-105099.00  
& #40-15099.001  
PINELLAS COUNTY**

**ENVIRONMENTAL ENGINEERING CONSULTANTS, INC.  
5119 NORTH FLORIDA AVENUE  
TAMPA, FLORIDA 33603  
EEC PROJECT #2021058**

**September 4, 2021**

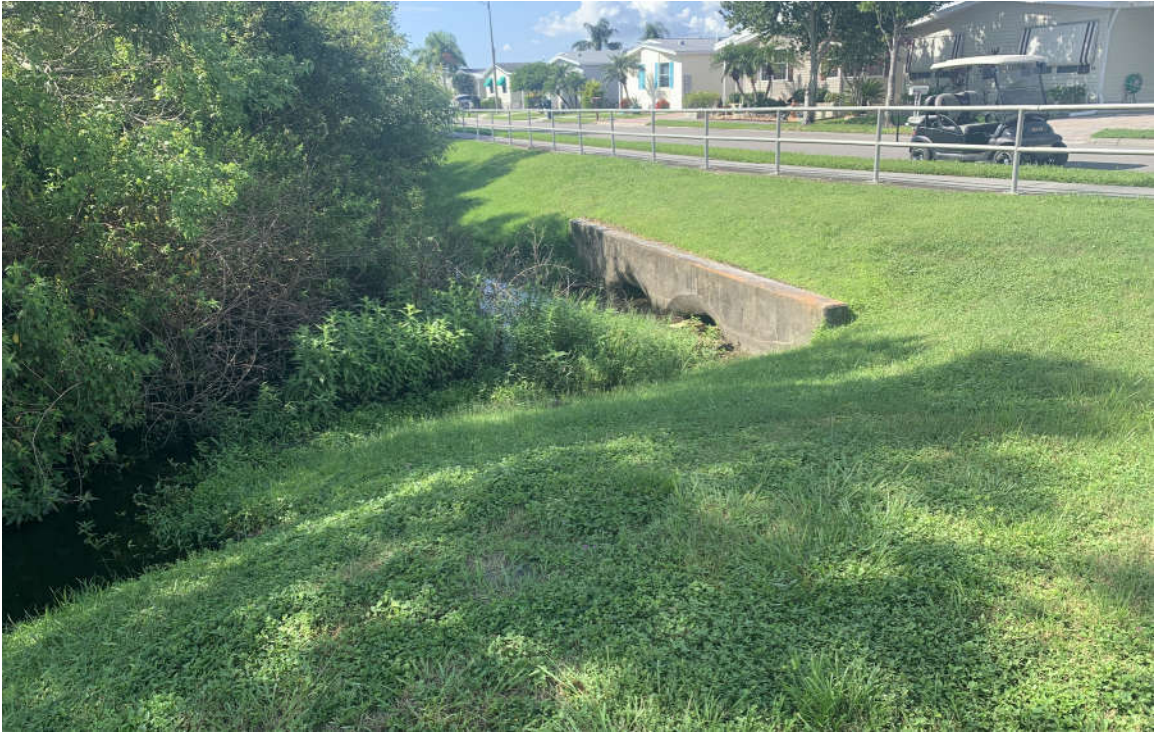
Continue to maintain vegetation (Northern spillway)

- Highest priority: replacement of concrete drainage outfall structures at the northern spillway, including side slope and channel slabs, the 'beehive' debris trap and threaded 6" PVC sleeve. EEC is connecting you with a retention construction specialist to continue the conversations regarding the necessary repairs to this structure
- Replacement of baffle/PVC post at overflow to wetland for Basin 2.
- Minor repairs to southern spillway, address erosion along the side slope and channel slab to prevent failure not unlike the northern spillway
- Stabilization/grading of basin shorelines, particularly for Basin 1. Addressing these issues in the near-term will prevent more costly maintenance in the future
- Continue to maintain vegetation, particularly invasive species (e.g. Brazilian pepper) where currently an issue.

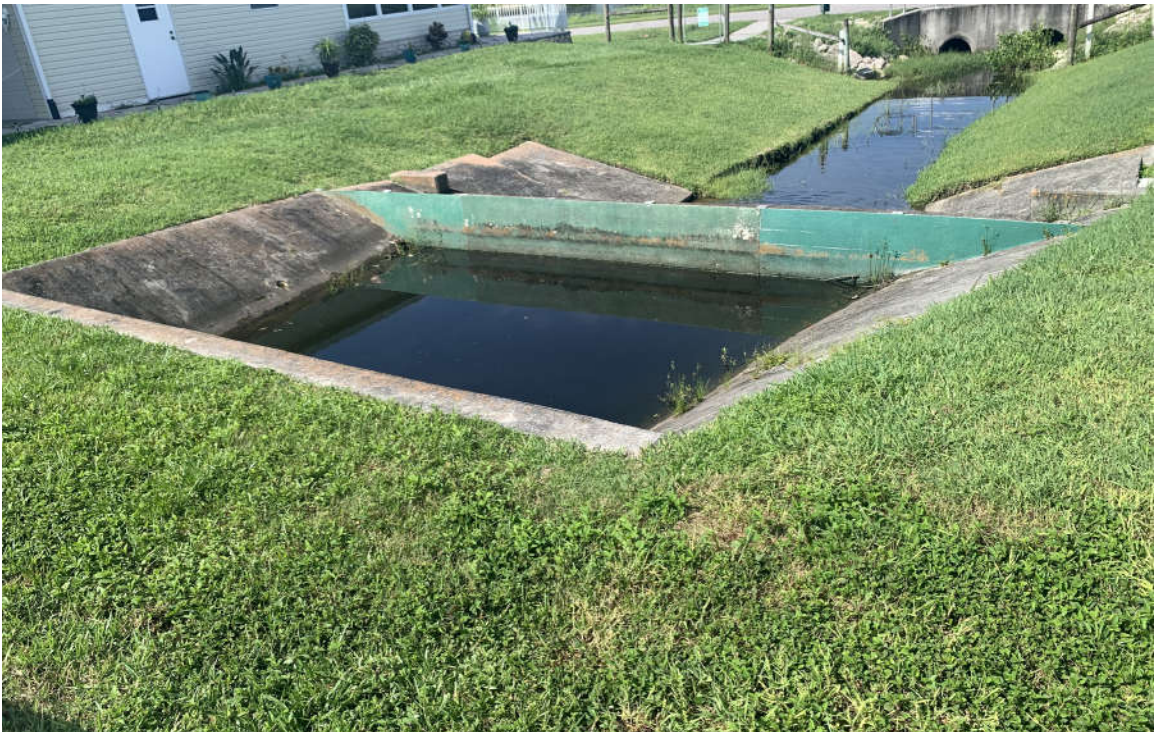
Northern Spillway

This wetland is located to the north of Basin 2. The overflow system has a 24" RCP that directs outflow to the south toward Alligator Creek. The pipe leads to a concrete outfall structure which releases water onto concrete rip-rap bags for energy dissipation. The water then flows down a natural grade toward the creek. Significant damage was observed at time of inspection, including side slope erosion, broken concrete slabs, and overgrown weepholes. In addition, the debris trap and threaded PVC sleeve were found to be broken.

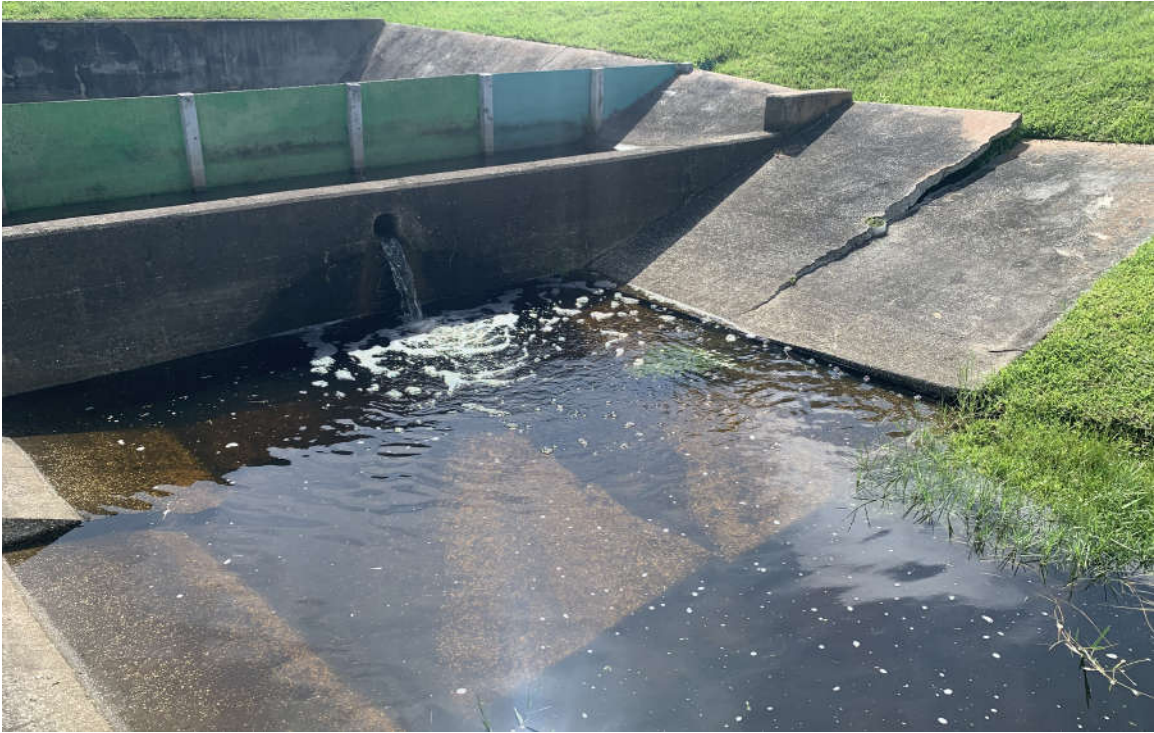
Cracked Concrete @ Northern Spillway

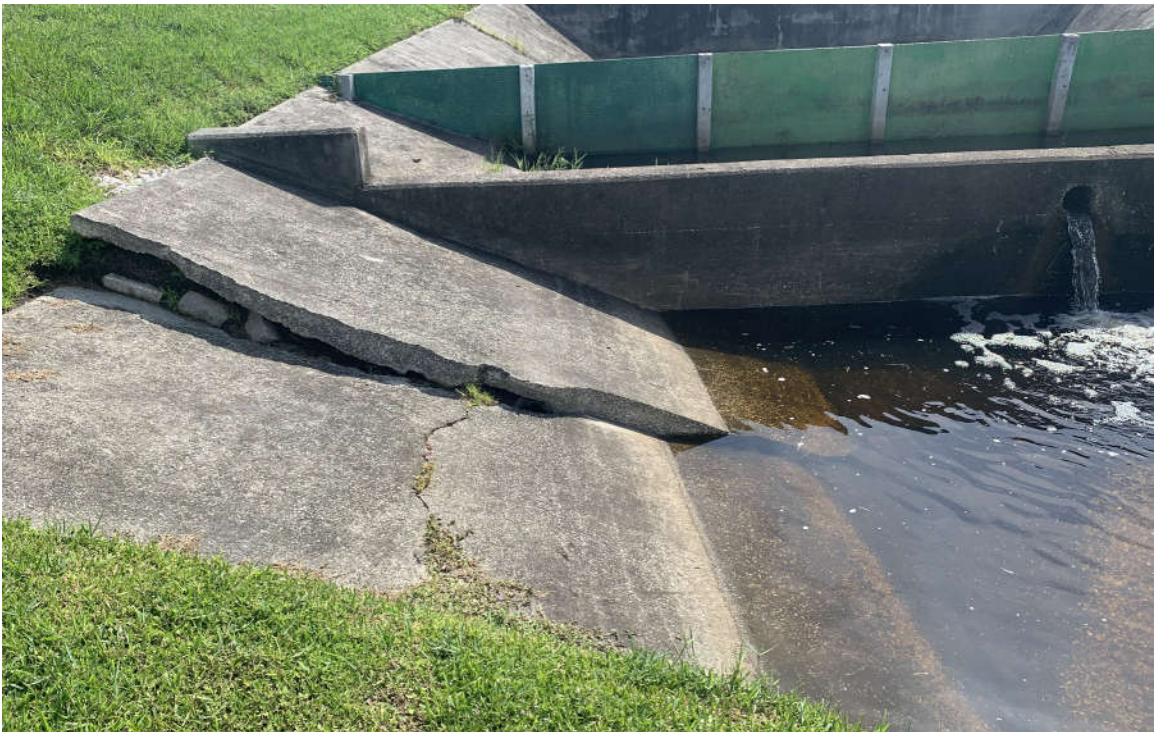
Cracked Concrete @ Northern Spillway

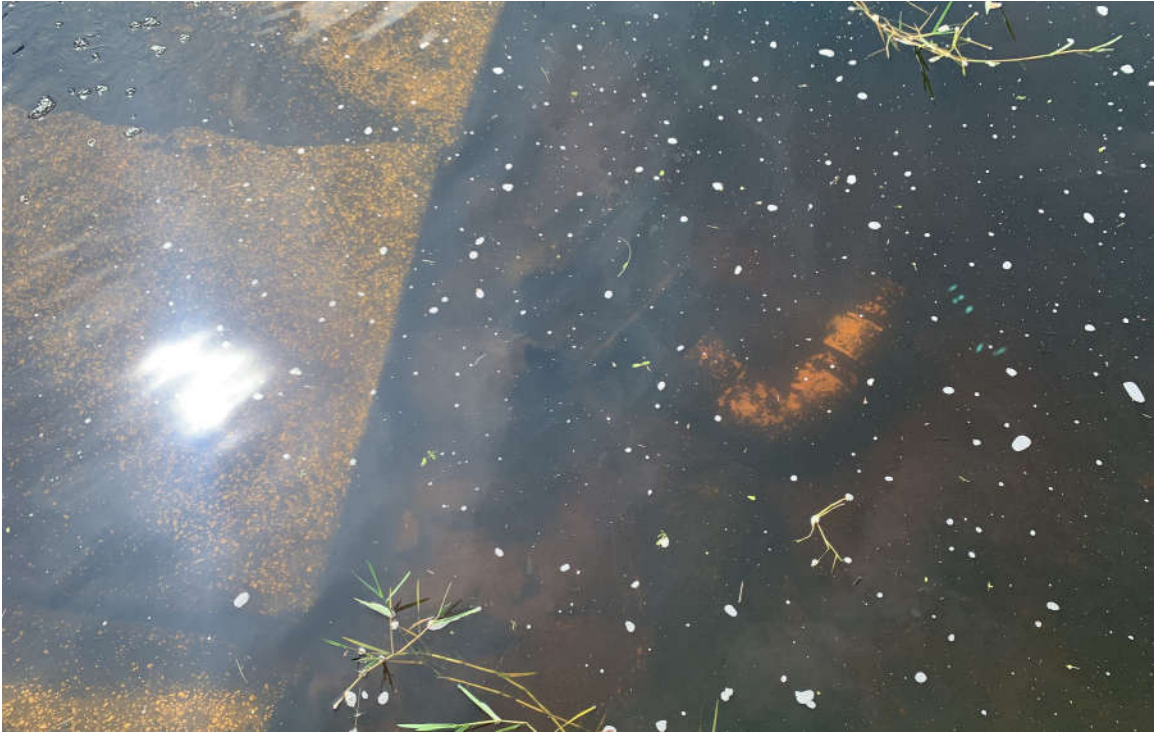
Broken Beehive Debris Trap @ Northern Spillway

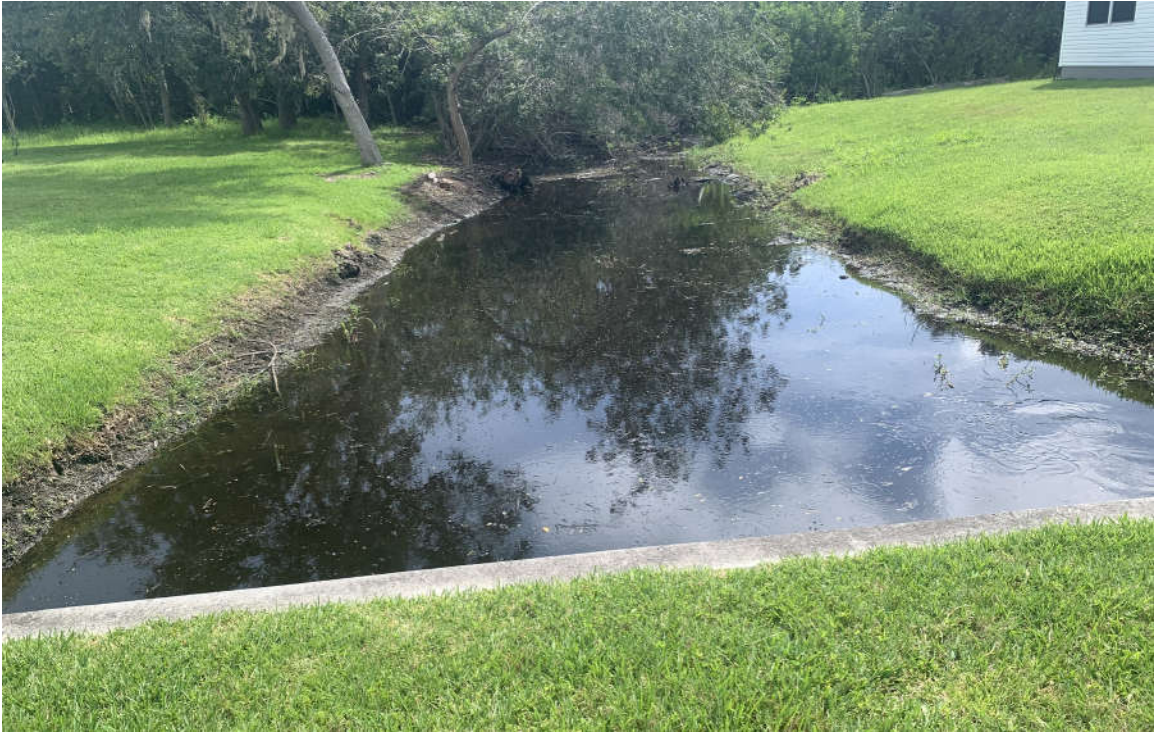
leads to a concrete outfall structure which releases water onto concrete rip-rap bags for energy dissipation. The water then flows down a natural grade toward the creek. Minor damage was observed at time of inspection, including side slope erosion, cracks in concrete slabs, and overgrown weepholes. In addition, the debris trap and threaded PVC sleeve were found to be broken.

Erosion at Southern Spillway

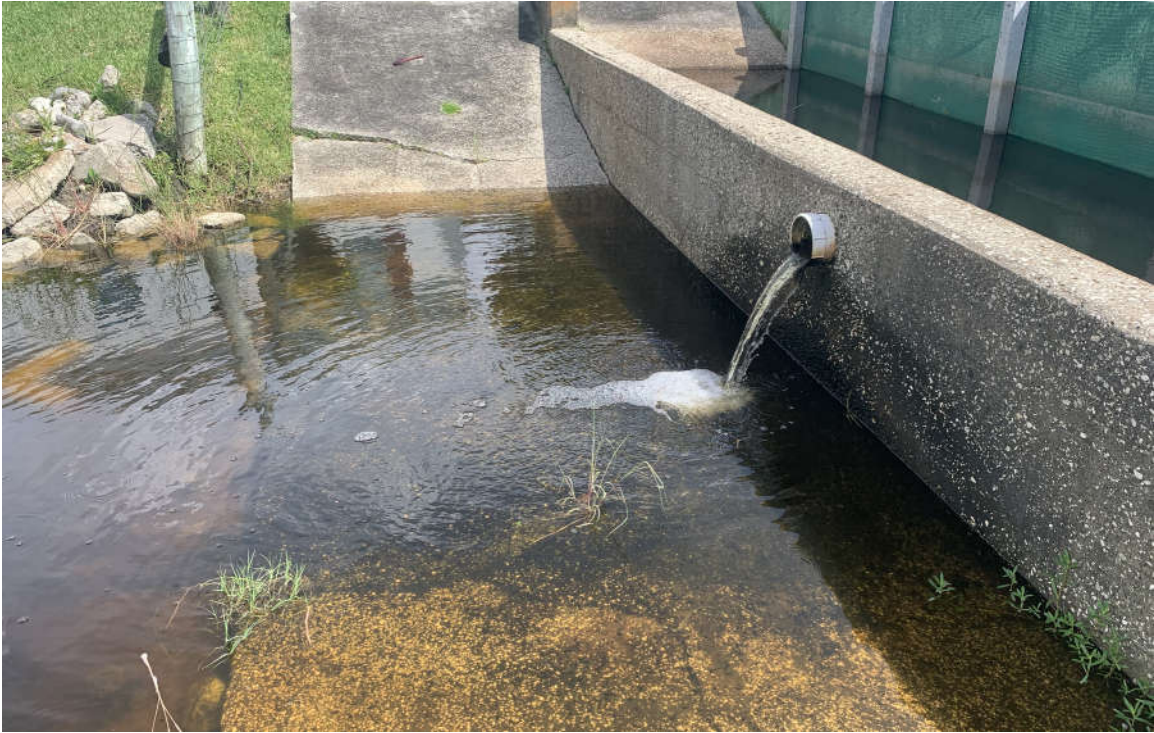
Southern Spillway missing Debris Trap, Cracking of Concrete

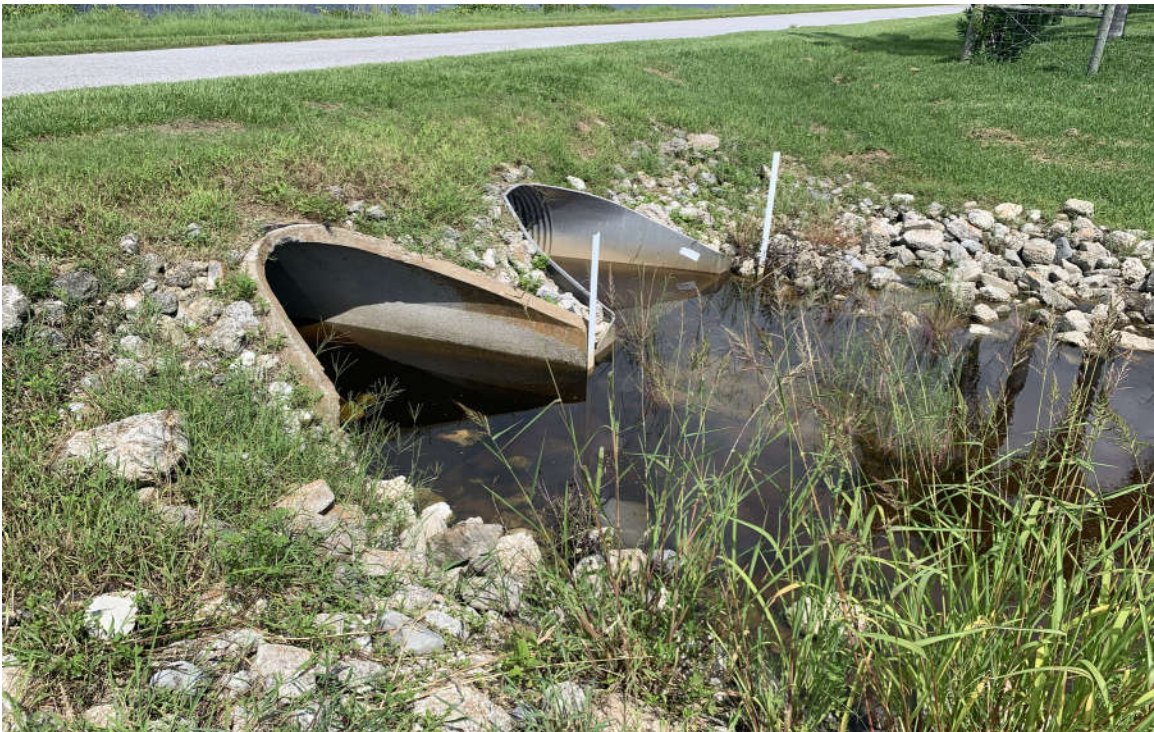
Southern Spillway Outlet (continue to maintain vegetation)

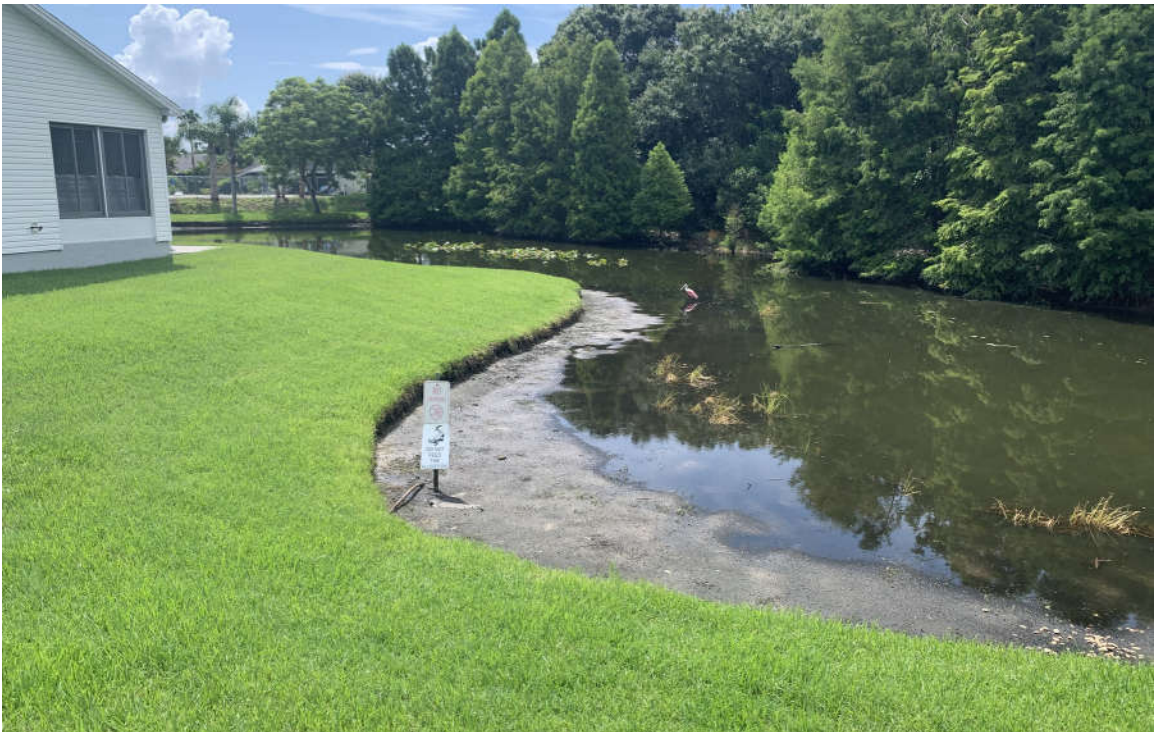
This basin is centrally located south of Pelican Dr S and Gull Aire Blvd, west of Sail Fish Blvd, and northeast of Trout Ln. Basin 1 is the largest basin on site, having a connection (via berm and baffle) to the southern wetland area. A walk along the circumference of this basin yielded a few objects of concern, including the following: broken/filled in PVC from the baffle, worsening bank erosion, and more significant erosion around the mitered end-wall of the storm culvert on the north bank.

Erosion of bank (Basin 1)

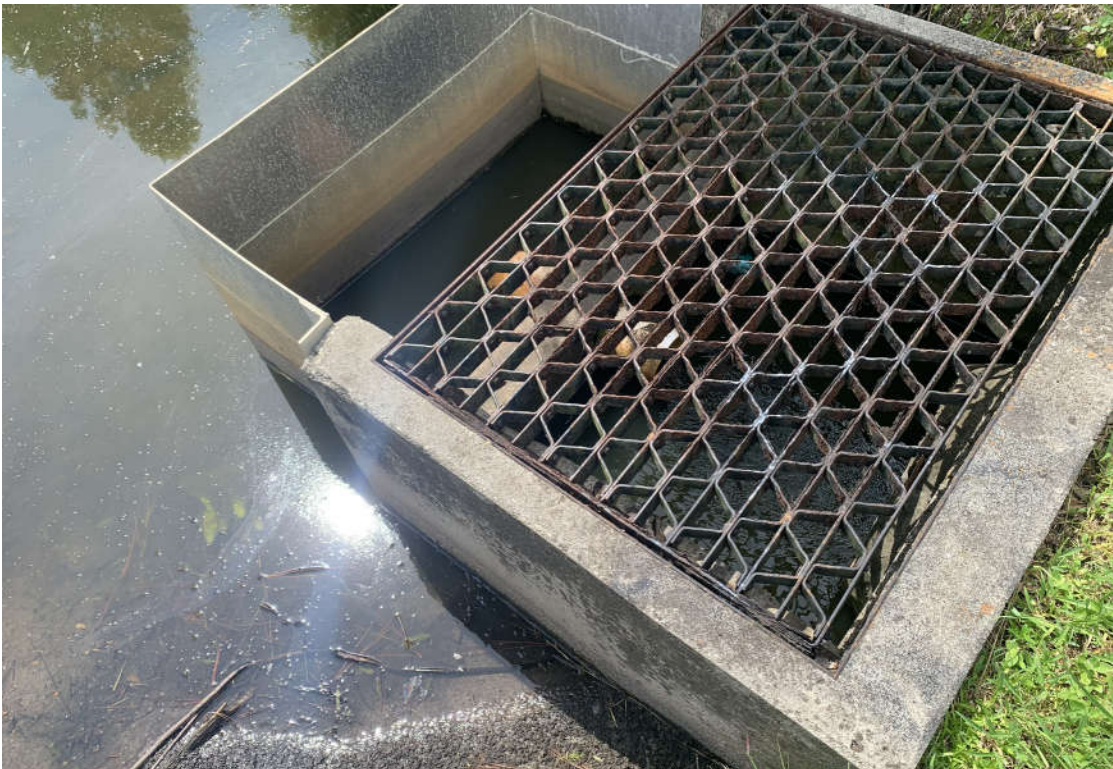
Overflow Structure Basin 5

This basin is south of Dove Terrace, an approximately 1.5-acre open-water pond with water lilies. There is an overflow structure on the basin which overflows to a wetland to the south. Beyond previously reported bank erosion, the pond and overflow structure do not have any significant issues at this moment.

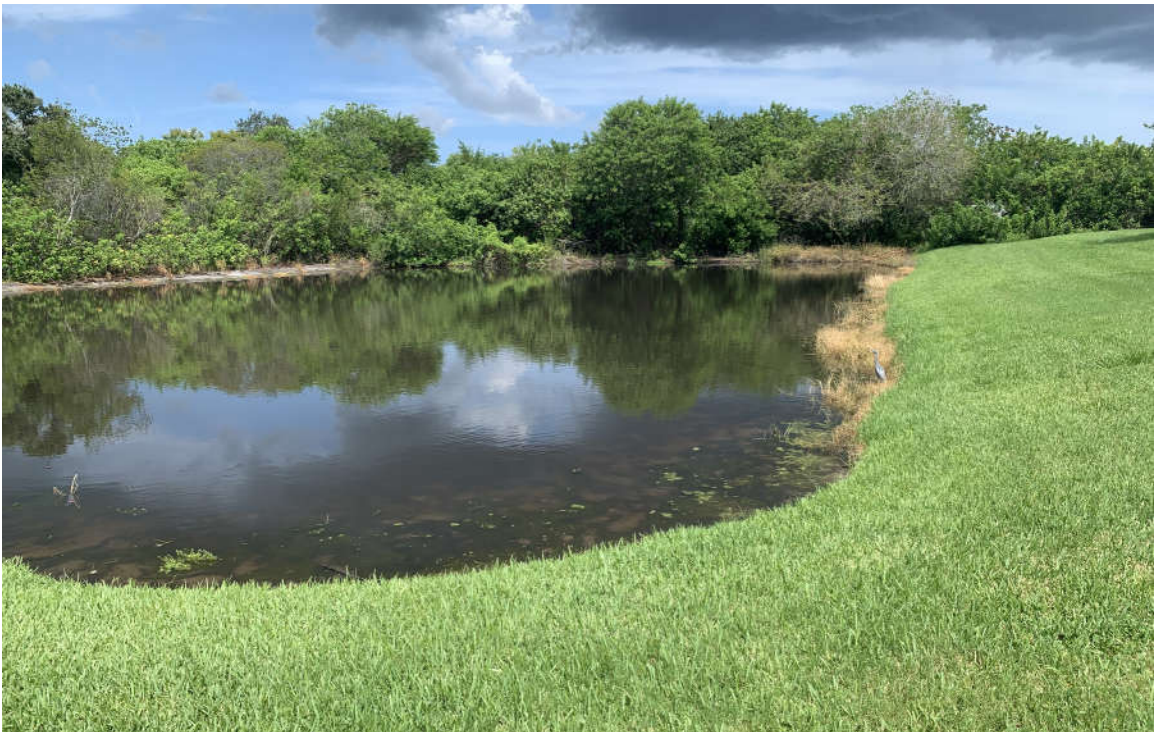
Basin 4

This basin is south of Salmon and Dove Terrace. There is an approximately 0.25 -acre open-water pond. There is a wetland to the north and south of this pond. The pond appears to be properly maintained and functioning.
